Case Studies: Storm Water Management

CLARK MONTESSORI HIGH SCHOOL Cincinnati, Hamilton County

ENABLED IMPACT PROJECT UPDATE

PROJECT: CLARK MONTESSORI HIGH SCHOOL

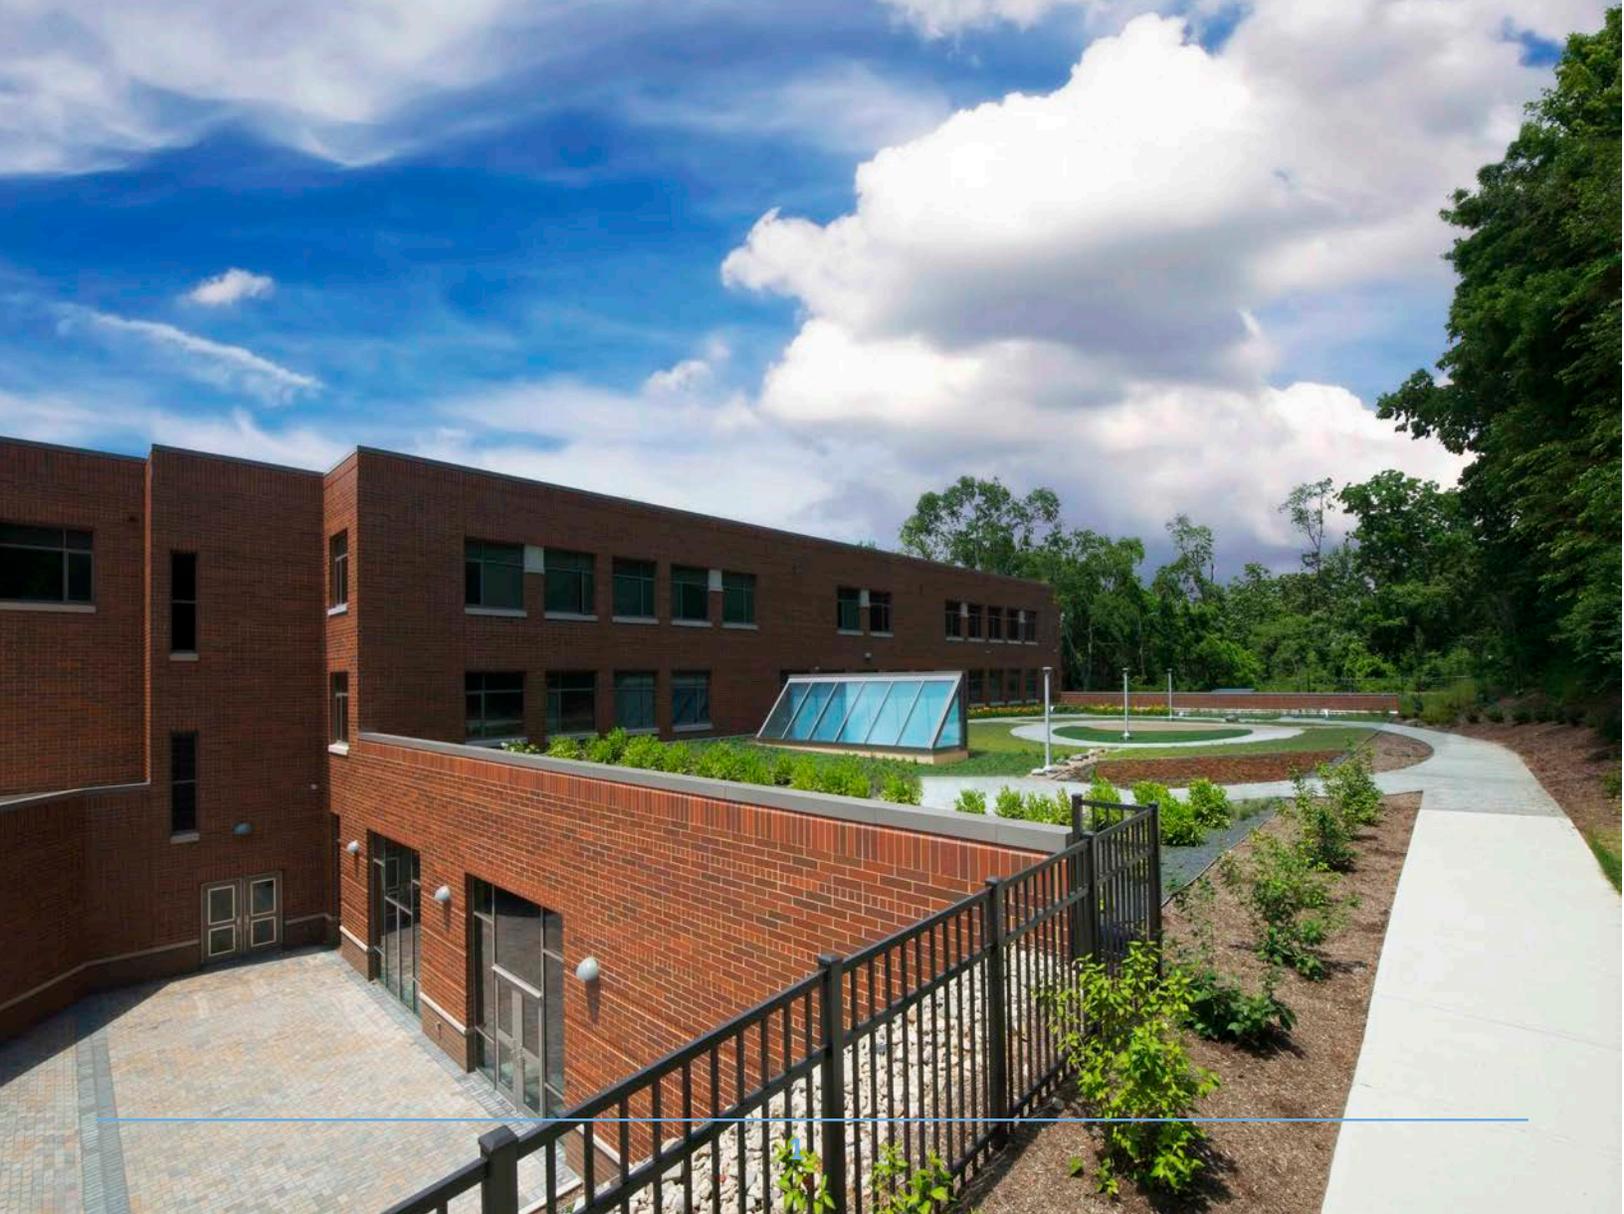
*Below: Clark Montessori High School Intensive Green Roof in Cincinnati
(photo: Glaserworks Architecture and Urban Design)*

Two vegetative roofs were installed at Clark: 9,200 sq. ft. of intensive roof and 5,500 sq. ft. of extensive roof. Both are layered rather than tray systems. The intensive roof, which can be accessed on foot from an adjacent hillside, includes a permanent sub-surface irrigation system.

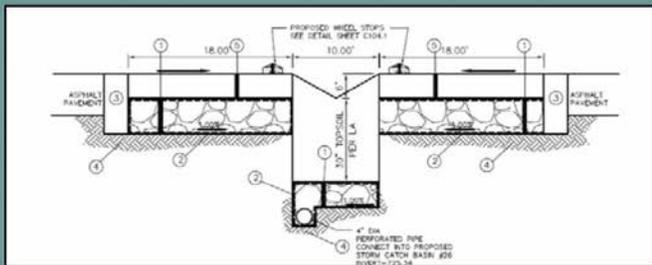
Cross Section of Porous Concrete and Bioswale

The porous concrete was poured without a permanent curb between the concrete and the bioswale. This was done to allow runoff to flow directly into the sub-surface of the bioswale after infiltrating through the porous concrete parking stalls. Wheel stops are used in place of a curb to stop cars from driving into the bioswale and compacting the soil. During construction, the perforated pipe was installed, but not connected to the downstream catch basin, as the soils were sandy enough for full infiltration of the runoff.

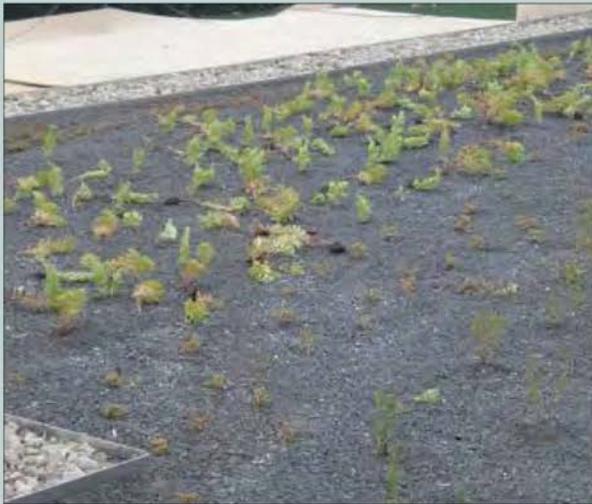
Uprooted plants on the vegetative roof.

The intensive and extensive vegetative roofs were planted prior to much of the other work being performed in the vicinity of the vegetative roofs. Construction taking place adjacent to and on the vegetative roofs disturbed—and in some cases killed—the plants on the roofs. Once installed, plants on vegetative roofs should be cared for until they are fully established. In this case, however, care was handed over to the roofing company. The landscape company returned to the site to tend to the plants once construction was finished. All the plants that were disturbed or killed were eventually replaced. Maintenance of the plants is now

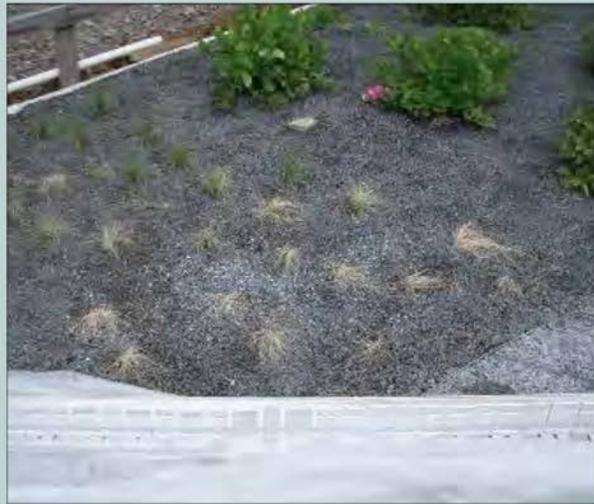
Dead plants on the vegetative roof.

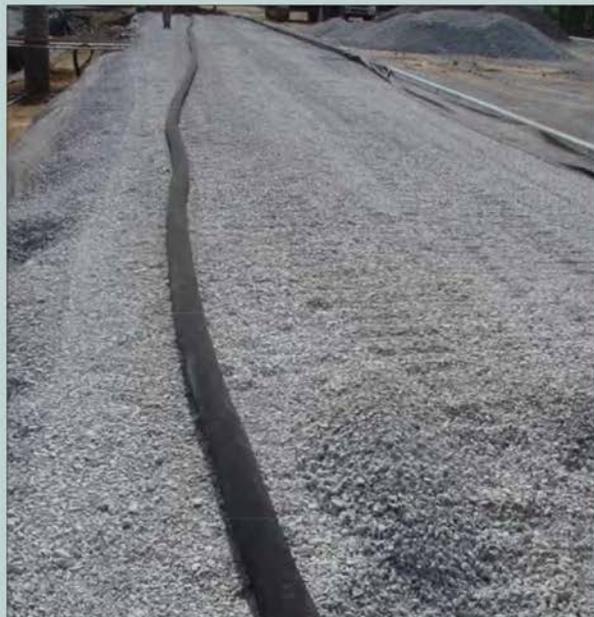
Underdrain to be installed in the bioswale.

Soil testing was completed on site, but not in the exact location of the proposed green feature locations. During construction, sand seams were found on site, which indicated that infiltration rates may be high, and therefore, underdrains may not be necessary. This finding was not brought to the attention of the design engineer or landscape architect on the project until much of the construction had occurred. At that point, one underdrain had already been installed, and all the underdrains for the site had been ordered. Although no additional soil testing was completed, the decision was made to plug the underdrain that was already installed and to install all other green features on site without underdrains. In some cases the engineered soil had also been placed. The soil contained sand, as per the design. The sand would make the feature drain too rapidly—so the engineered soil was removed and replaced with a non-sand soil mixture. This additional effort and cost may not have been necessary.

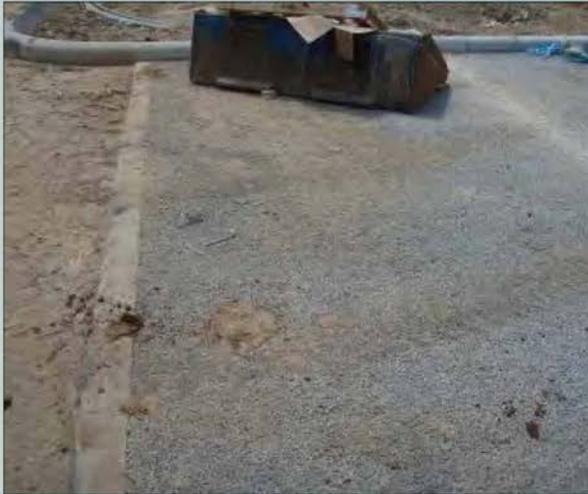
Exposed dirt adjacent to the newly installed porous concrete can cause sediment build up and clog the system.

Sediment build up from mud on construction equipment was tracked over the gravel base of a pervious paver parking lot. Once the pavers were installed, this machinery continued to travel across the pavers with mud on the tires, causing the system to clog prematurely. In addition, the plastic was removed from the pervious concrete before finishing construction in the surrounding area, allowing excess silt and sediment to accumulate in the voids. The property owner will need to have the pavement area vacuumed to remove these materials.

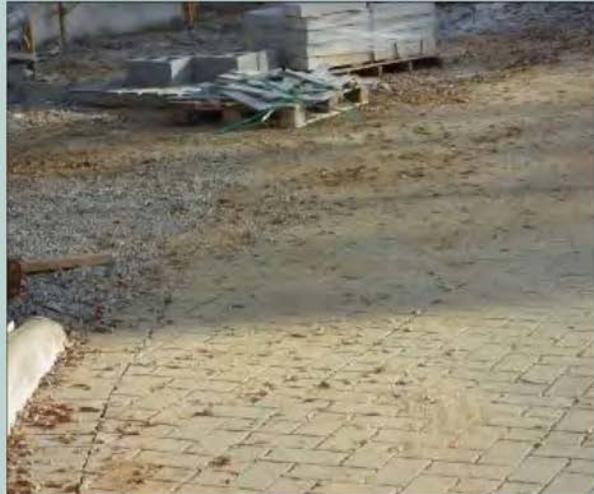
Exposed dirt adjacent to the newly installed porous paver system can cause sediment build up and clog the system.

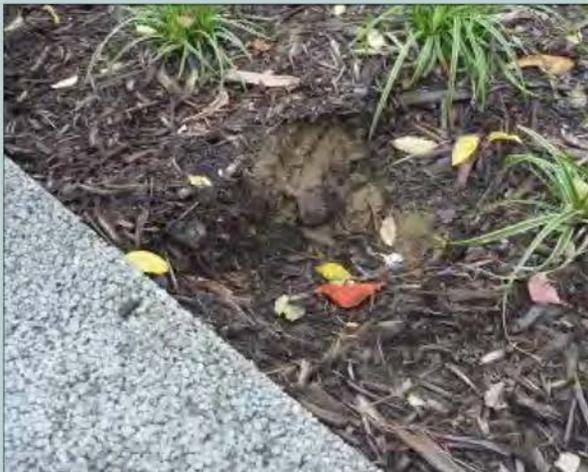
Tire ruts in the soil.

Parking blocks were not included in the design of this parking lot bioswale. Students and staff using the lot have accidentally driven their cars over the edge of the parking stalls, getting stuck in the bioswale and causing ruts in the amended soil. Parking blocks were placed prior to opening the parking lot to the general public. Bollards are to be installed at either end of the bioswale.

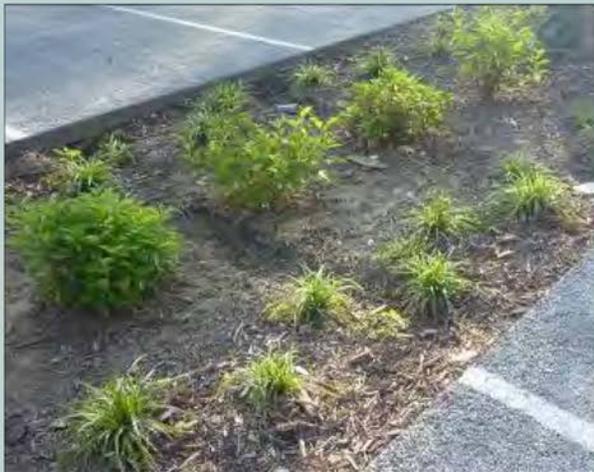
Tire ruts in the soil.
